# IR Inspections of Power Transformers

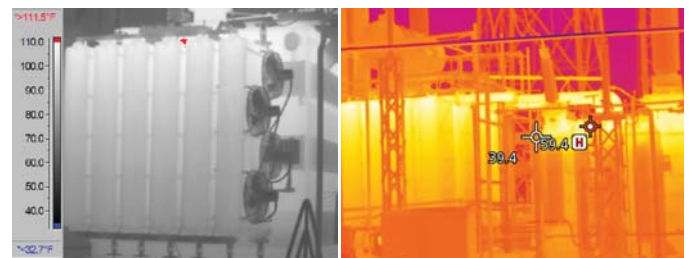
Normal transformer IR pattern

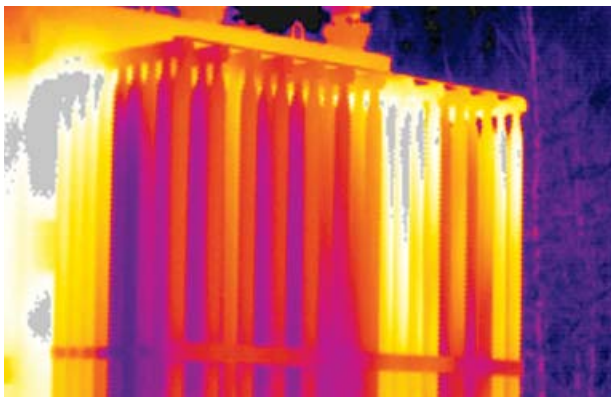
Inspection of transformer radiators is conducted by an IR camera and then compared with each other. A cool radiator or segment indicates that either a valve is closed or the radiator or segment is plugged. The reference IR image below shows that, the cold left radiator section is plugged or blocked with internal corrosion of the fins. If visual inspection shows that the valves are open then the radiator or segment must be isolated, drained, removed, and the blockage must be cleared. Operation of the transformers with reduced cooling should be strictly prohibited as it can drastically affect the transformer life. It is important to note that generally an increased operating temperature of only 8 to 10 °C will reduce transformer life by one-half. Hence IR scanning of all cooling systems, including heat exchangers, fans, pumps, motors, etc is advisable. There is also a need to check inside the control panels for overloaded wiring, loose connections, and overheated relays. Additionally, observation for unusual thermal patterns and comparing with similar equipment is necessary.

Abnormal pattern for transformer radiator

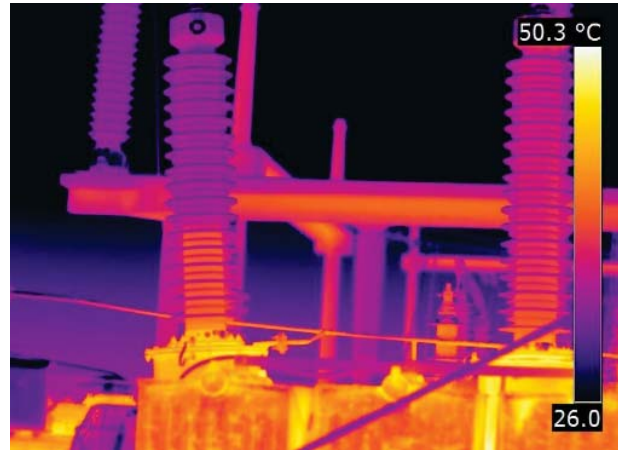
Thermograph showing abnormal bushing

At the top of the capacitive bushing, the media of heat transmission is the air, which is bad conductor of heat, while at the bottom the whole of heat transmission is through the oil. Bushings are susceptible to leakages of transformer oil due to worn out seats and may lead to explosive failure of a transformer. These defects can sometimes be easily rectified, improving transformer service life.

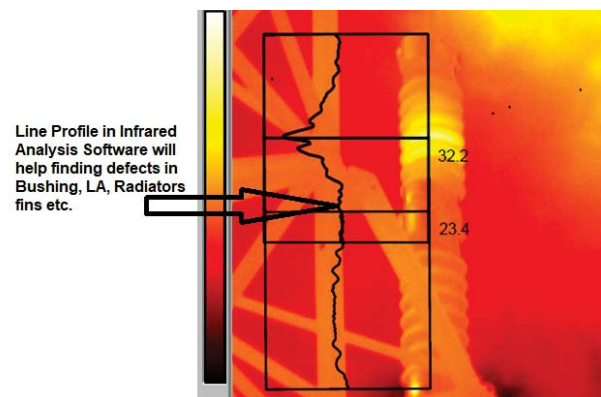
Surge arresters are important while conducting infrared scanning on energized transformers. Unusual thermal patterns on the surface of lightning arresters can be seen in the below thermograph. The yellow color in the top right of the image is just a reflection not associated with the arrester. A temperature profile of the arrester is shown as black lines. Actually, the hot spot (yellow part) as we move little down from the top, indicates that an immediate de-energizing process and replacement must be undertaken. Catastrophic failure is imminent which can destroy nearby equipment and can be hazardous to workers too. It is good to compare thermal patterns of the similar units or baseline scan of the same arrester. Even the high-voltage connections should be scanned and compared to nearby connections for unusual temperatures.

IR image of defective arrester

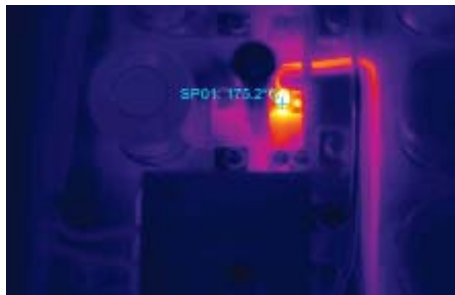
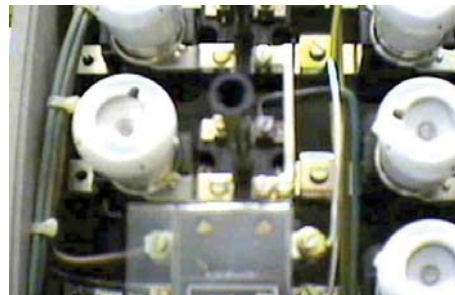
The neutral conductor may get overheated significantly if the specified limits of above parameters are crossed. Below thermal image shows such overheated neutral conductor.

The presence of third-order, zero sequence harmonic currents may also result in an overload on a transformer's neutral terminals. At severe levels of harmonic currents, the neutral currents may exceed the phase currents. Any time a thermographer notices the neutral terminal of a transformer heating up, it is likely that severe harmonic conditions exists. Thermography of neutral conductor / bus bar is necessary whenever there are sudden changes in load profile or drastic change in load power factor or the transformer voltage and current either on primary or secondary side are crossing their limits. This will enable us to take corrective actions well before there is any significant loss.
